Investigation of Rock Slope Stability Using Drone-Based Thermal Sensor

Abstract- This study focuses on the investigation of rock slope stability using a drone-based thermal sensor. In this study, a compact remote sensor of visible spectrum (400–700 nm) and infrared thermography spectrum (7,500–13,500 nm) was used to develop a method for monitoring the stability of rock slope failure in terms of temperature. This study used two datasets of each sensor that were collected in two different phases. The first phase was conducted during the dry season, which was completed in October 2019. Meanwhile, the second phase was carried out during the wet season in December 2019. The study area is located at a rock slope structure of KM 257.5 to KM 258.3, which is approximately 800 m in length at the North-South Expressway (PLUS). The location is situated after the Menora tunnel in Jelapang, Perak, Malaysia, facing southbound. This study is helpful in illustrating how drone-based remote sensing is implemented in rock slope investigations. The results from this study indicate that rock slope instability can be identified through the thermal image of surface temperature. Finally, this study determ

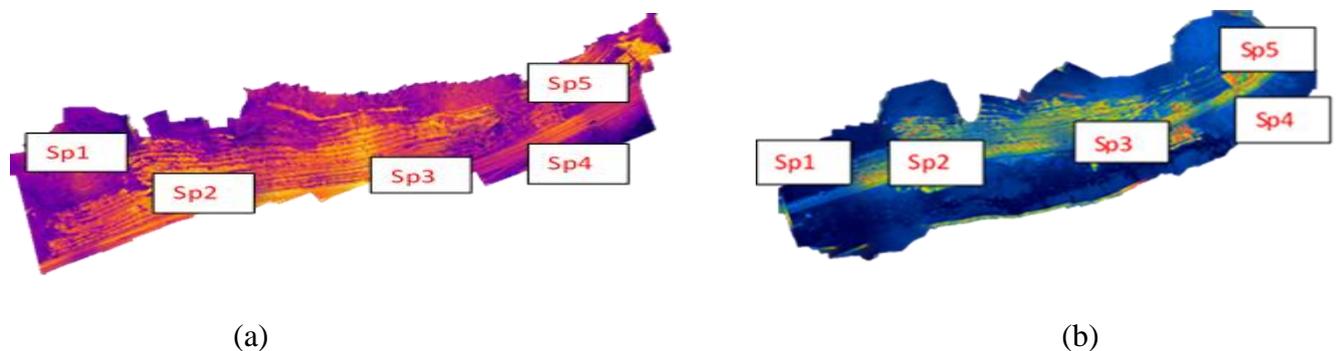
Figure 7: Surface mapping of (a) phase 1 and (b) phase 2 generated by Pix4Dmapper software.

The results of phase 1 of this study have shown that high-temperature surface coverage is more than cooler temperature. It can be seen in Figure 7 (a) that there are more “iron” brighter coloured areas than the darker coloured areas. This is because the data in phase 1 were collected in the dry season in October 2019. Meanwhile, the surface mapping of phase 2 in Figure 7 (b) shows that the surface coverage with cooler temperature is more obvious. It can be observed that the dark blue colour dominates the mapping of the surface and overshadows the yellow and

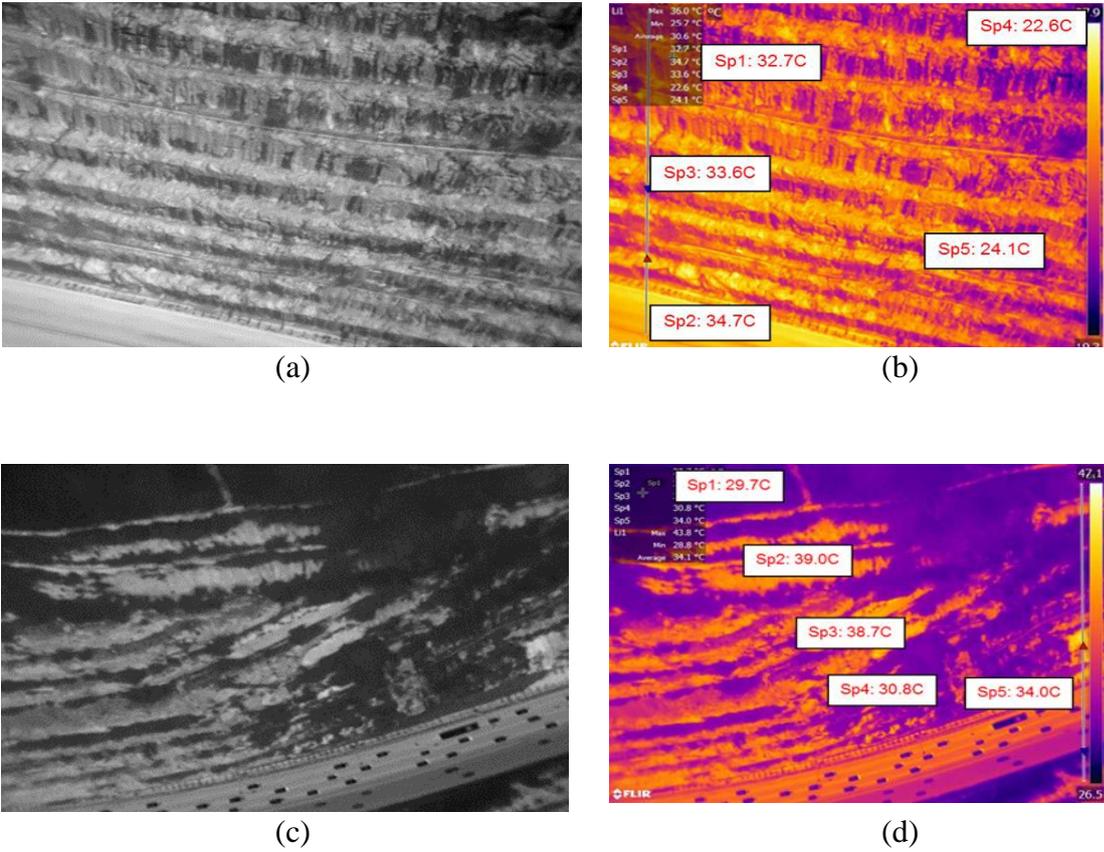
Figure 9: (a) The black hot image of Sp2 in phase 1 from a drone-based thermal sensor, (b) the thermal photo from FLIRR software in phase 1, (c) the black hot image of Sp2 in phase 2 from a drone-based thermal sensor, and (d) the thermal photo from FLIRR software in phase 2 (Sp2 is a rock slope area).

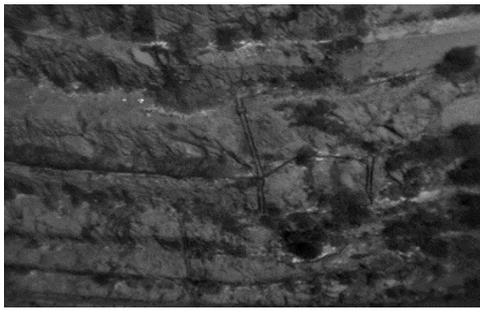
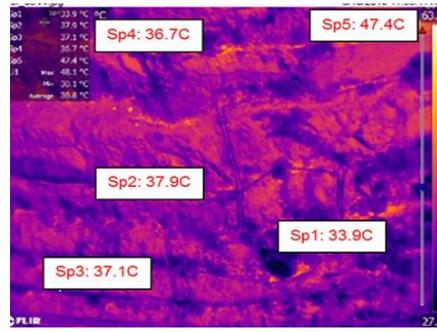
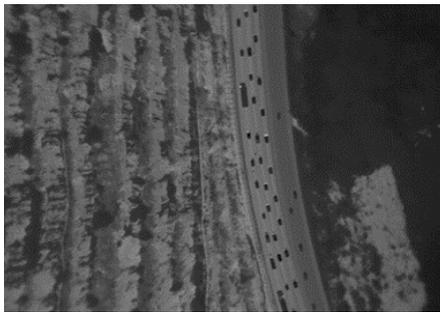
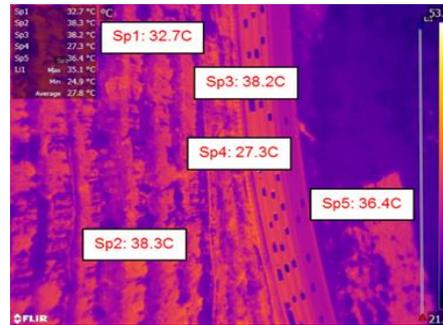
Figure 12: (a) The black hot image of Sp5 in phase 1 from a drone-based thermal sensor, (b) the thermal photo from FLIR software in phase 1, (c) the black hot image of Sp5 in phase 2 from a drone-based thermal sensor, and (d) the thermal photo from FLIR software in phase 2 (Sp5 is a rock slope area).

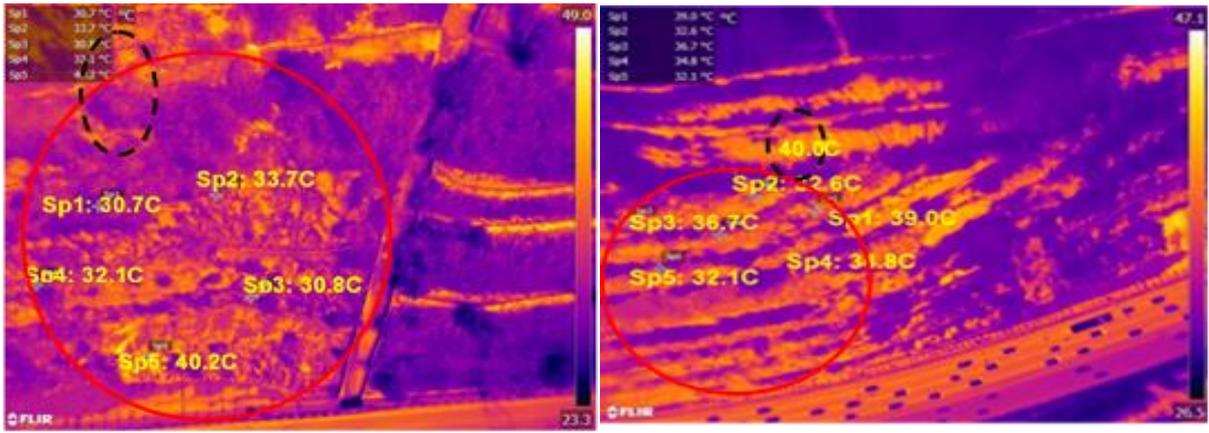
Figure 13: Planar failure temperature of (a) phase 1 and (b) phase 2 in the study area.

Figures 13 (a) and 13 (b) to 16 (a) and 16 (b) show the image pairs for phase 1 and 2 based on the temperature for different types of rock slope failure. For planar rock slope failure, the surface temperature of phase 1 ranges between 30.7 °C and 40.2 °C in the dry season. Meanwhile, the temperature range of phase 2 is from 32.1 °C to 39.0 °C during the wet season. For wedge rock slope failure, the temperature range of phase 1 is between 26.3 °C and 26.6 °C and between 29.6 °C and 32.2 °C for phase 2 . The temperature ranges of toppling rock slope failure in phase 1 and 2 are from 25.3 °C to 28.5 °C and from 25.9 °C to 35.6 °C, respectively. Finally, the temperature range of circular rock slope failure in phase 1 is between 29.4 °C and 40.9 °C and between 37.4 °C to 43.8 °C for phase 2. This result shows that thermal anomaly is related to slope instabilities in terms of rock slope failure. The surface temperature is represented by different means of colour scale. Warmer and cooler temperatures are displayed by lighter and darker colours, respectively. Thus, the surface temperature between 25.9 °C and 28.5 °C is under cooler temperature anomalies, while the surface temperature between 28.6 °C and 43.8 °C is considered warm temperatures.

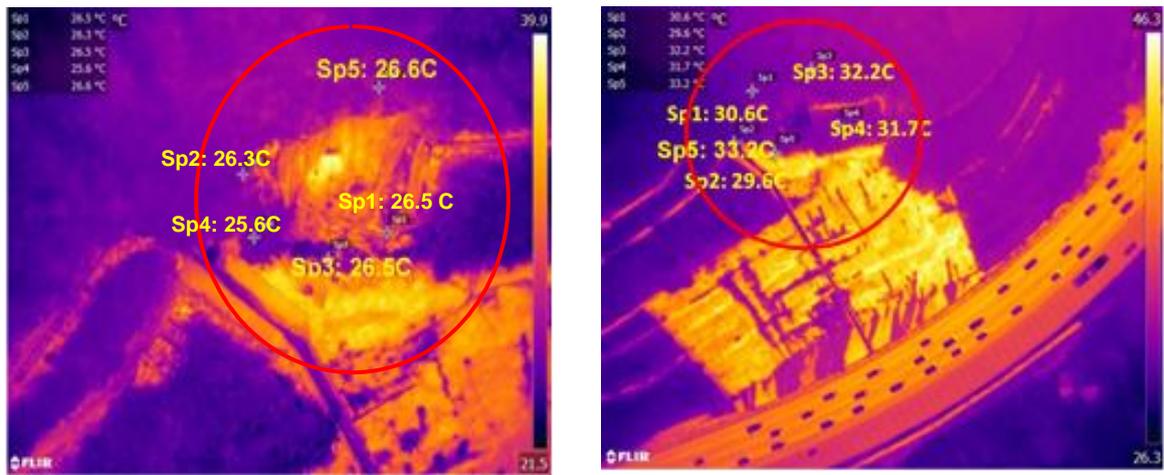
Figure 14: Wedge failure temperature of (a) phase 1 and (b) phase 2 in the study area.

Wedge and toppling failure could occur in phase 1. The temperature range detected for planar and circular failure did not differ significantly in phase 1 and 2. Hence the probability of occurrence of planar and circular failure is similar for both phases. Although the temperature range for phase 2 is higher than phase 1, it does not mean that rock slope failure will not occur in phase 2. Many factors influence rock slope failure other than surface temperature. According to Ulusay [35], four main factors including lithology (rock type), structure (discontinuities), state of degradation, and hydrogeological conditions prevailing in rock slopes can lead to slope failure. The instability in slopes primarily depends on the relationship between driving and resisting forces and the slope height increased the slope susceptibility for instability [14].

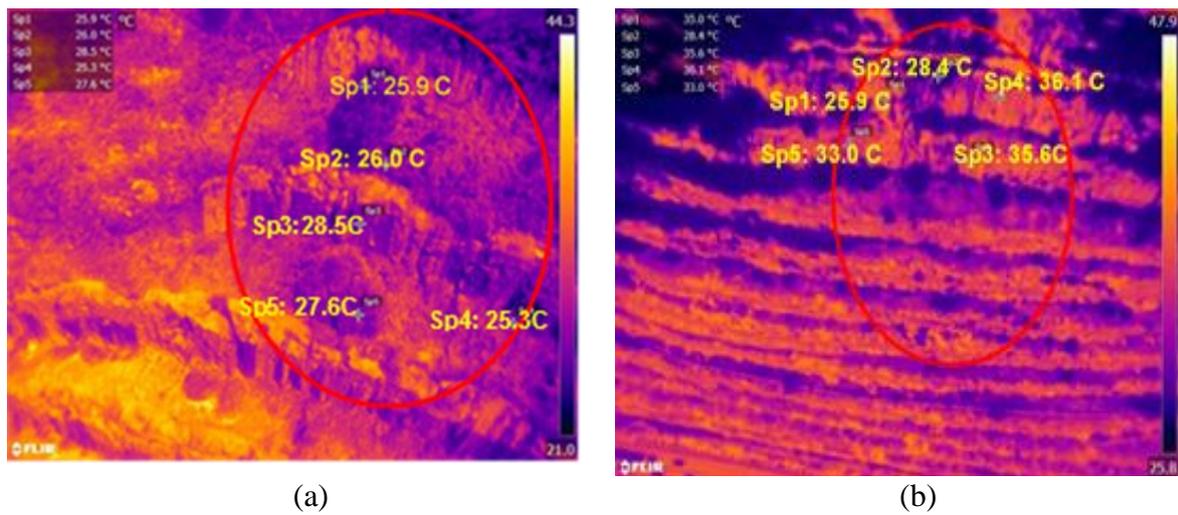
Figure 15: Toppling failure temperature of (a) phase 1 and (b) phase 2 in the study area.

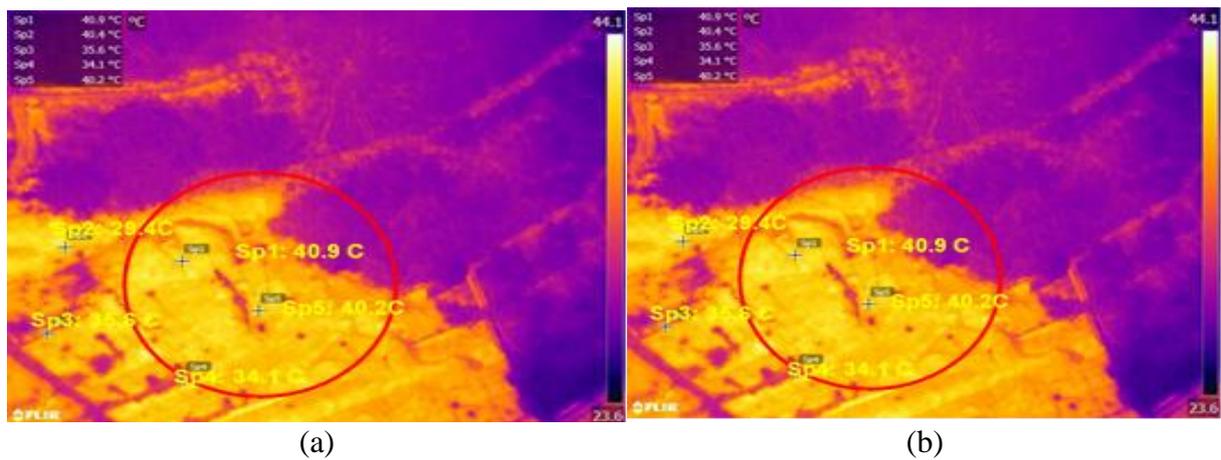
Figure 16: Circular failure temperature of (a) phase 1 and (b) phase 2 in the study area.
