Bridge Pillar Inspection Using Thermography and Multispectral Images

Abstract - Bridges play a vital role in the transportation sector, which is crucial to human life and the economy. To monitor the underlying deterioration of concrete bridges, this study investigates the potential use of unmanned aerial vehicles (UAVs) equipped with multispectral and infrared thermography sensors. The study area of this research was located at North-South Expressway Central Link (ELITE) Highway. A secondary multispectral and primary thermal images were used to inspect a bridge pillar's concrete surface fault. Using low-altitude planes, a high-resolution thermal camera was used to capture thermal images during the inspection process. A software program was used to improve the photos and stitch them together to create a mosaic thermal image of the entire bridge pillar. The mosaic thermal imaging image was segmented using K-means clustering, with the image analysis using the highest value thermal pixel in the image as the seed pixel. The results were then verified using multispectral photos taken using a high-resolution digital camera to evaluate the state of the surface. This study has successfully

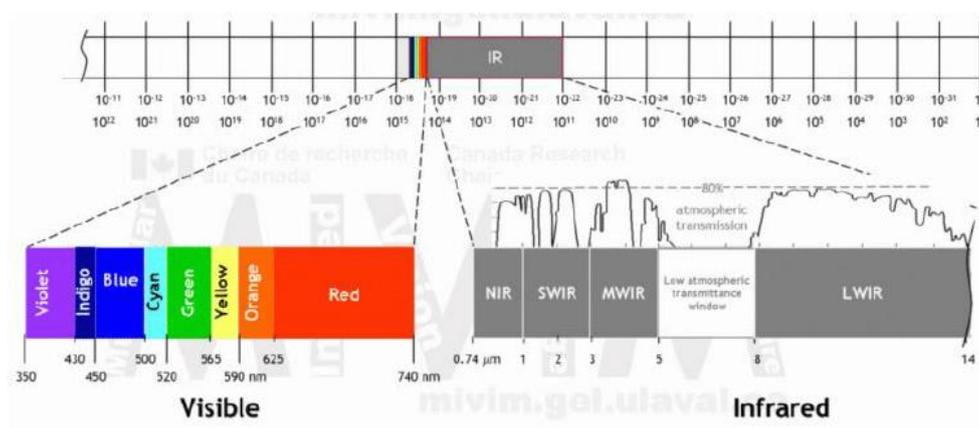
Figure 1. The electromagnetic spectrum (Akhloufi & Bendada, 2013)

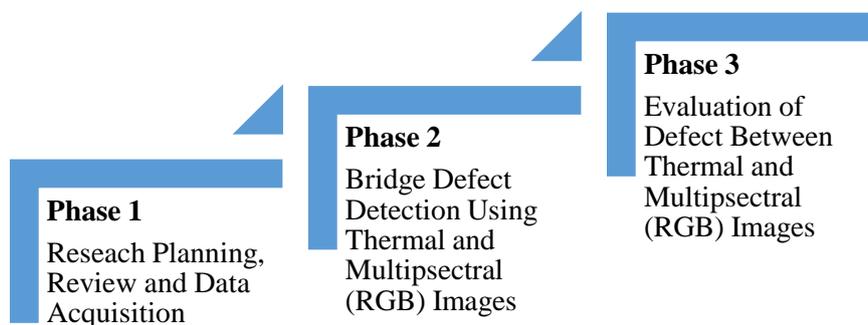
Figure 2. The framework of the research methodology

A research methodology is proposed to complete the research work systematically within the time frame. It is divided into three phases, as shown in Figure 2.

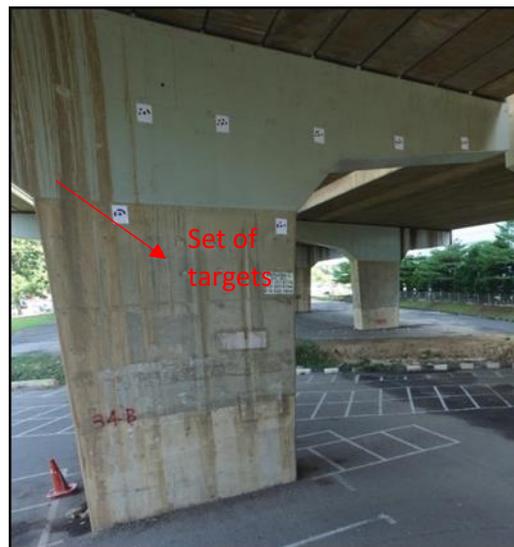
Figure 3. Example of targets

A set of targets was placed on top of the pillar surface to aid the photogrammetric processing. The target coordinate was measured using the tachometry technique from two stations. All the coordinates will be computed based on the assumed coordinate of the control station.

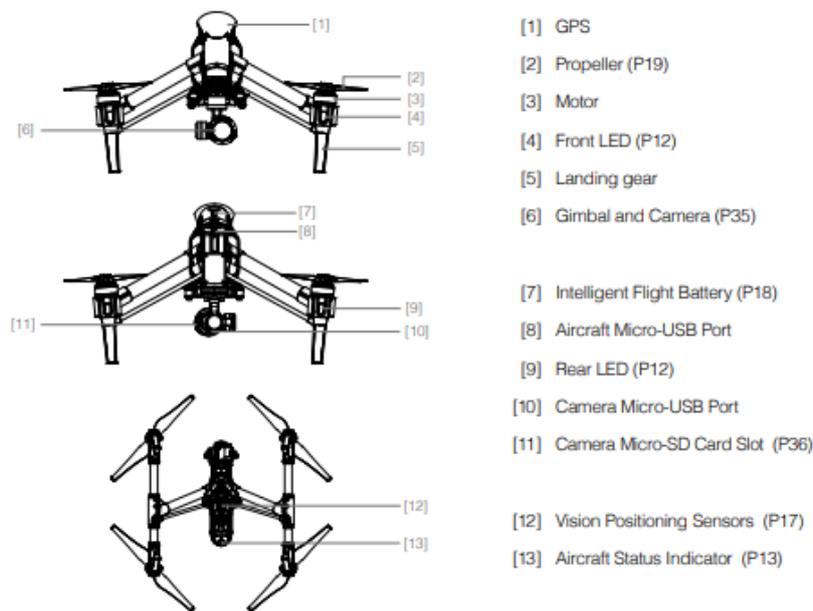
Figure 5. Aircraft component of DJI Inspire 1

For the entire airborne data collecting procedure to gather photographs of bridge pillars, the DJI Inspire 1 model is utilised as the UAV platform. A photographic platform that is ready to fly straight out of the box is the DJI Inspire 1. It has an on-board camera with a lens, stabilised gimbal, and retractable landing gear that can be pulled out of the way to provide the camera with an unhindered 360-degree view of the landscape below. The capabilities and safety of this type of UAV model were other factors in its selection, and the rotors' symmetrical placements help to maintain the UAV's planar angle.

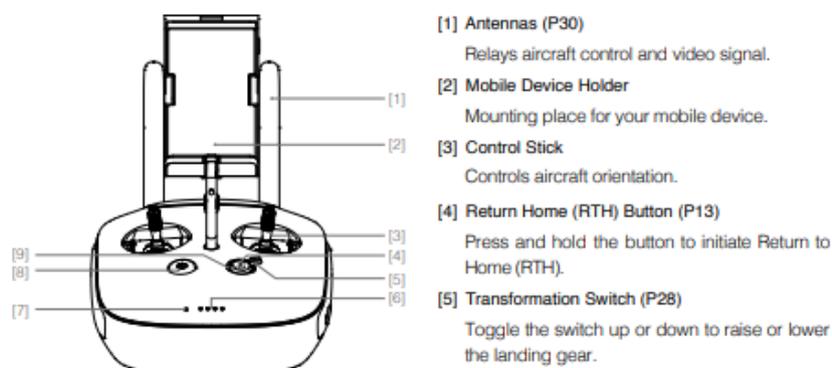
Figure 6. Remote controller component of DJI Inspire 1

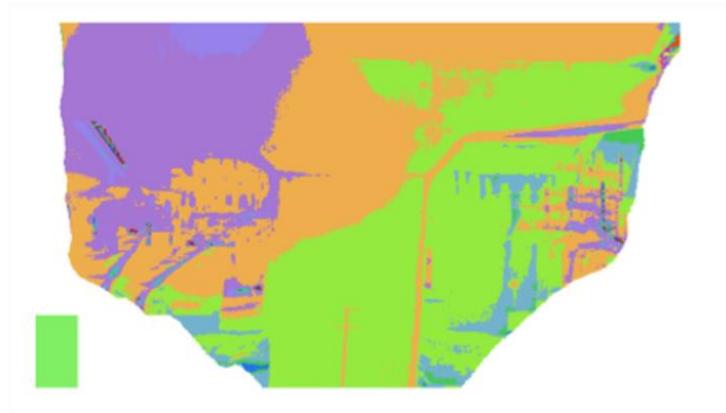
Figure 7. Thermal Mosaic by Pix4D Mapper software

Due to the difference in geometric and radiometric features of photographs, both thermal and RGB datasets were processed separately in Pix4D software. The same procedure of photo alignment is implemented on both image datasets to generate a tie point; however, for thermal photographs, the need to neatly connect to the control point target on the image to orientate the photographs due to low spatial resolution. Both images will be combined into a new processing project in Pix4D Mapper, one successfully oriented. The tie point and photo orientation information were maintained. The photo orientation information is used to generate a dense

point cloud based on RGB photographs, while the texture of the 3D model is generated based on thermal images. The vertical feature of the pillar was set up to extract the thermal mosaic. Figures 7, 8 and 9 show the output of processing from thermal and multispectral sensors for bridge pillars.

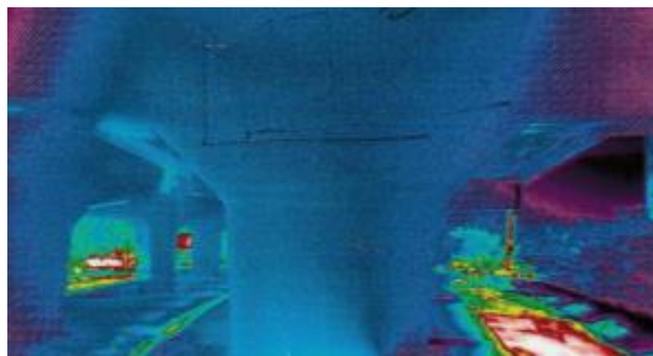
Figure 8. Thermal Mosaic by Flir Tools + software

The image stitching processed by FLIR Tools+ is straightforward, commenced by importing the images into the FLIR Tools+ workspace. By using panorama mode, FLIR Tool+ stitched together several smaller images into a larger one by analysing each image to detect

pixel patterns that match pixel patterns in other images. The successful mosaic is then saved as a new file in *.jpg format for downstream analysis.

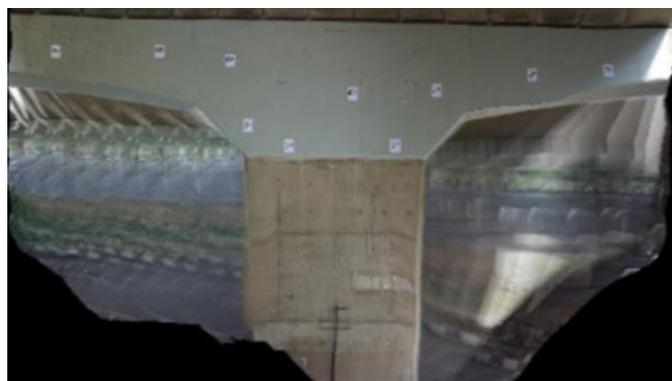
Figure 9. Mosaic RGB images of the bridge pillar

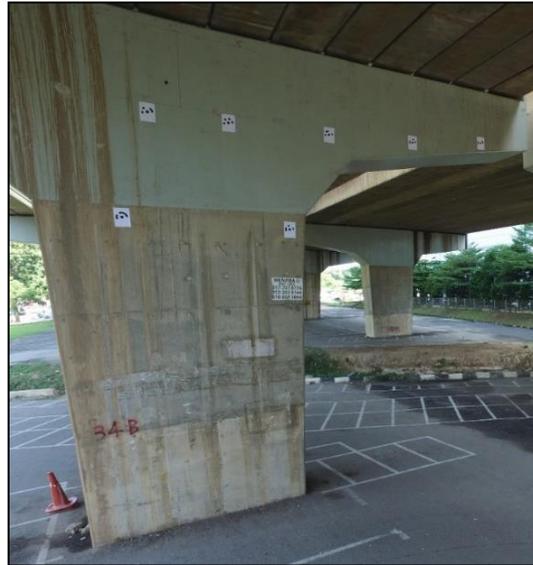
Figure 10. Bridge 34B for the testing

A pillar of the bridge named 34B was the subject of the testing. A spot was recognised visually as a potential crack, namely spot 1. The spot was captured with Zenmuse XT thermal camera. Figure 11 shows spot 1 of the possible crack on pillar 34B. Figure 12(a) is the raw thermal image in jpeg format directly from the thermal camera, while 12(b) is the respective thermal image in a different colour palette (Rainbow). One can see the temperature distribution in the image with a colour palette. The higher temperature is at the upper part (pier cap), and the low temperature is towards the bottom (pier column).

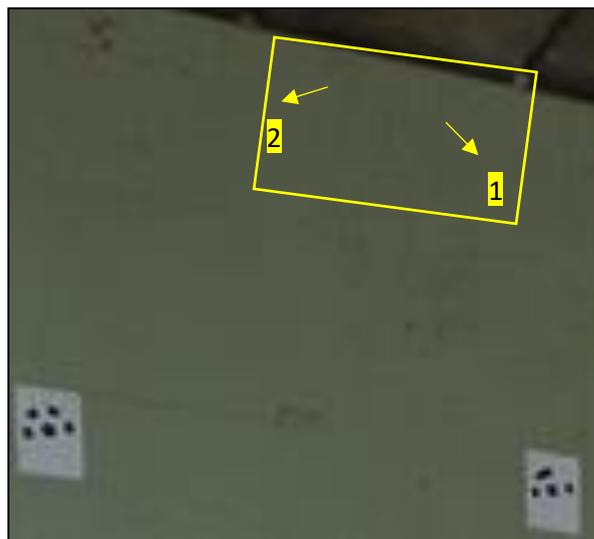
Figure 11. The potential crack of spot 1

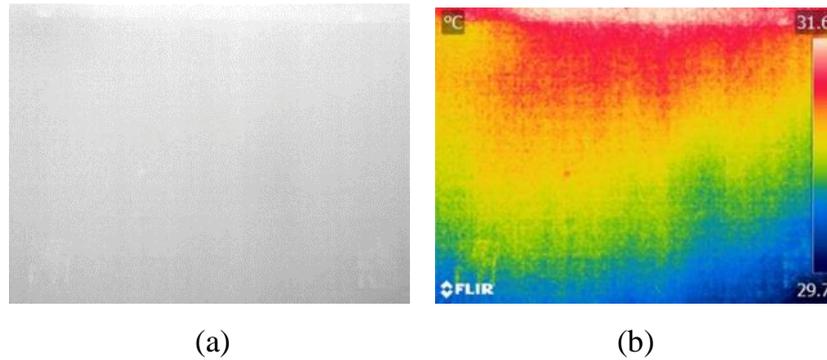
Figure 12. Thermal results of a spot (a) raw thermal image and (b) rainbow palette of the thermal image

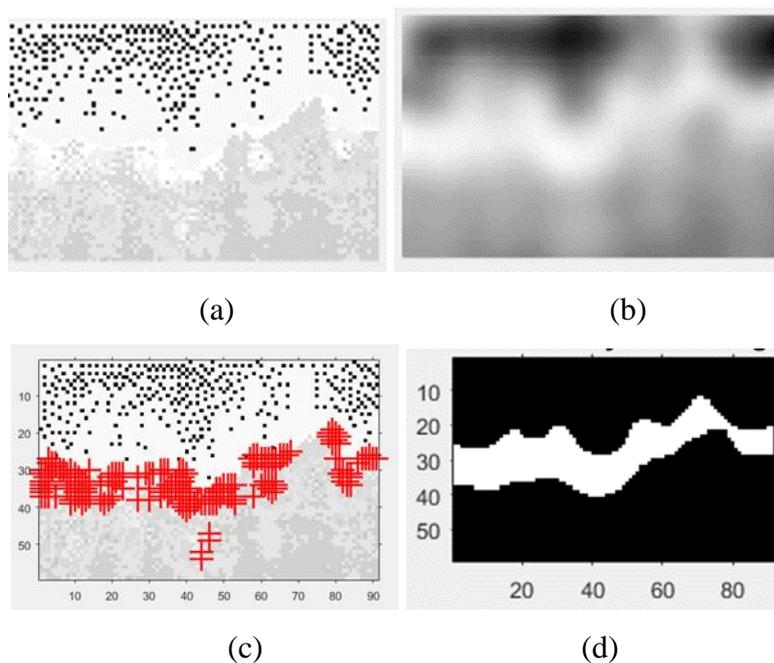
Figure 13. Segmentation result of spot 1 pillar 34B

Figure 13(a) is the original grayscale image from the conversion of the pseudocolour image in Figure 13(b). Figure 13(b) is the pre-processed image after applying a filter to remove noise, the resulting image exhibit better contrast. Figure 13(c) marks the pixel with the hottest spot as a cross to indicate the potential occurrence of a crack on the bridge pillar. Figure 13(d) is the K-means clustering image with five predefined clusters.

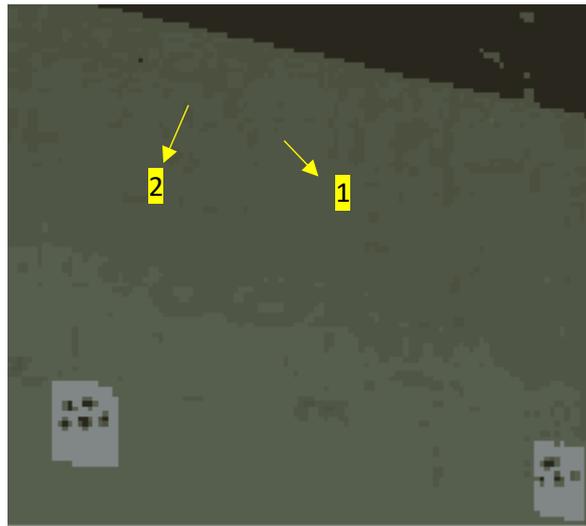
Figure 14: Segmentation RGB image of pillar 34B

Figure 14 shows the implementation of K-means clustering to the potential crack area on bridge 34B with the same clusters as thermal image segmentation. In detecting cracks on bridge piers, by implementing the same number cluster of K-means clustering, RGB gives better results than thermal images specifically for defect detection of the concrete bridge. This evaluates that the thermal image depends on the excellent heat source for analysis. For RGB image, it provides a true colour image which a real-life image can be replicated, which is determined by a combination of red, green, and blue intensities stored in each colour plane at the pixel's location. In another aspect, the thermal image contrasts potential defects and non-defect on the concrete bridge surface.
