Investigation of Rock Slope Stability Using Drone-Based Thermal Sensor

Abstract- This study focuses on the investigation of rock slope stability using a drone-based thermal sensor. In this study, a compact remote sensor of visible spectrum (400–700 nm) and infrared thermography spectrum (7,500–13,500 nm) was used to develop a method for monitoring the stability of rock slope failure in terms of temperature. This study used two datasets of each sensor that were collected in two different phases. The first phase was conducted during the dry season, which was completed in October 2019. Meanwhile, the second phase was carried out during the wet season in December 2019. The study area is located at a rock slope structure of KM 257.5 to KM 258.3, which is approximately 800 m in length at the North-South Expressway (PLUS). The location is situated after the Menora tunnel in Jelapang, Perak, Malaysia, facing southbound. This study is helpful in illustrating how drone-based remote sensing is implemented in rock slope investigations. The results from this study indicate that rock slope instability can be identified through the thermal image of surface temperature. Finally, this study determ

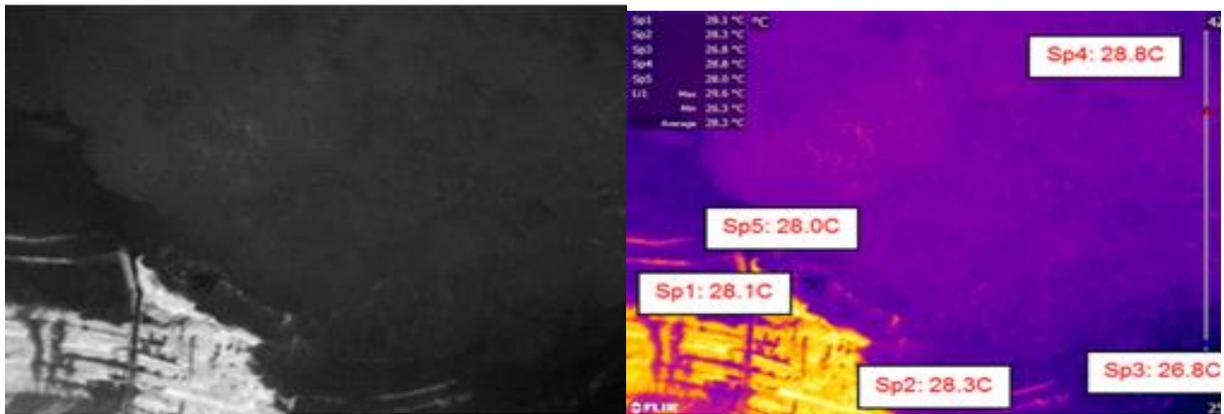
Figure 8: (a) The original image of Sp1 in phase 1 from a drone-based thermal sensor, (b) the thermal photo from FLIRR software in phase 1, (c) the black hot image of Sp1 in phase 2 from a drone-based thermal sensor, and (d) the thermal photo from FLIRR software in phase 2 (Sp1 is a vegetation area).

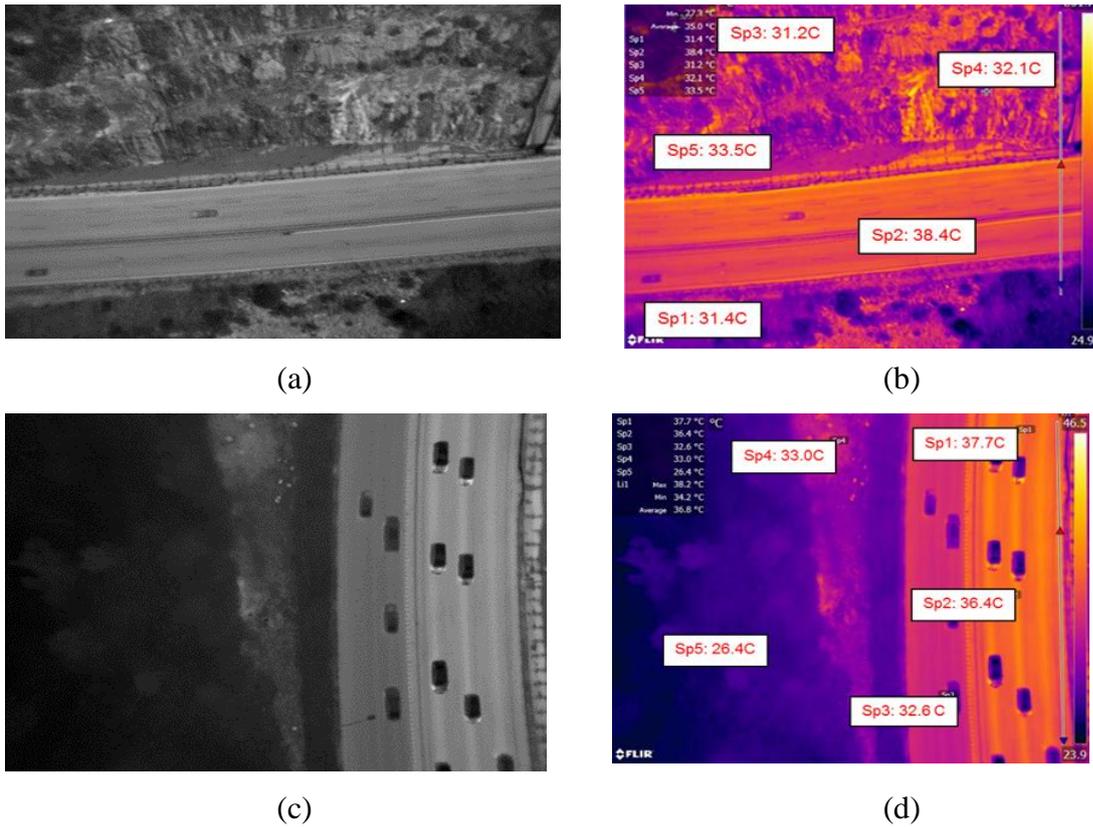
Figure 10 (a) The black hot image of Sp3 in phase 1 from a drone-based thermal sensor, (b) the thermal photo from FLIRR software in phase 1, (c) the black hot image of Sp3 in phase 2 from a drone-based thermal sensor, and (d) the thermal photo from FLIRR software in phase 2 (Sp3 is a road way area).

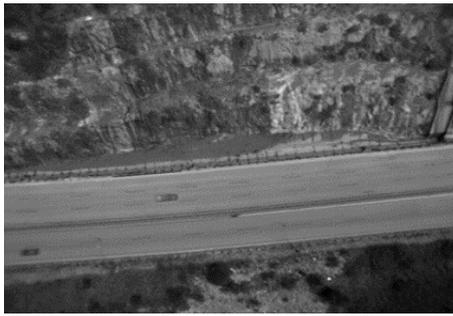
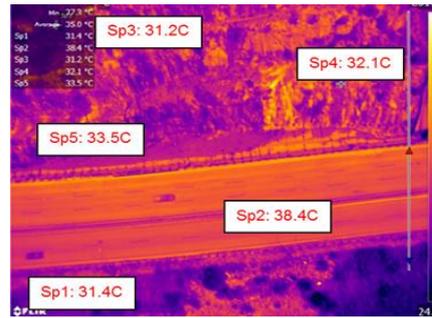
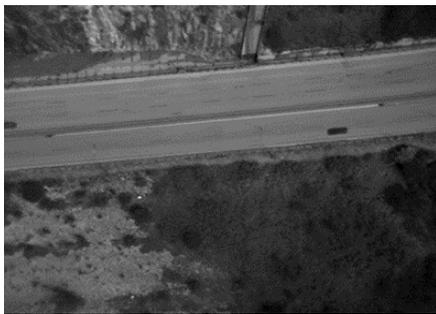
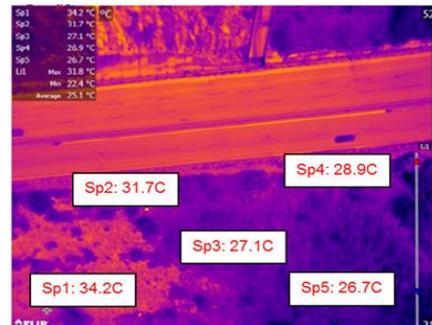
Figure 11: (a) The black hot image of Sp4 in phase 1 from a drone-based thermal sensor, (b) the thermal photo from FLIRR software in phase 1, (c) the black hot image of Sp4 in phase 2 from a drone-based thermal sensor, and (d) the thermal photo from FLIRR software in phase 2 (Sp4 is a ravine beside the roadway area).
